TWG Meeting (5/20/04)

Summary of April 2004 Shutdown Activities – R. Klaffky, AOD

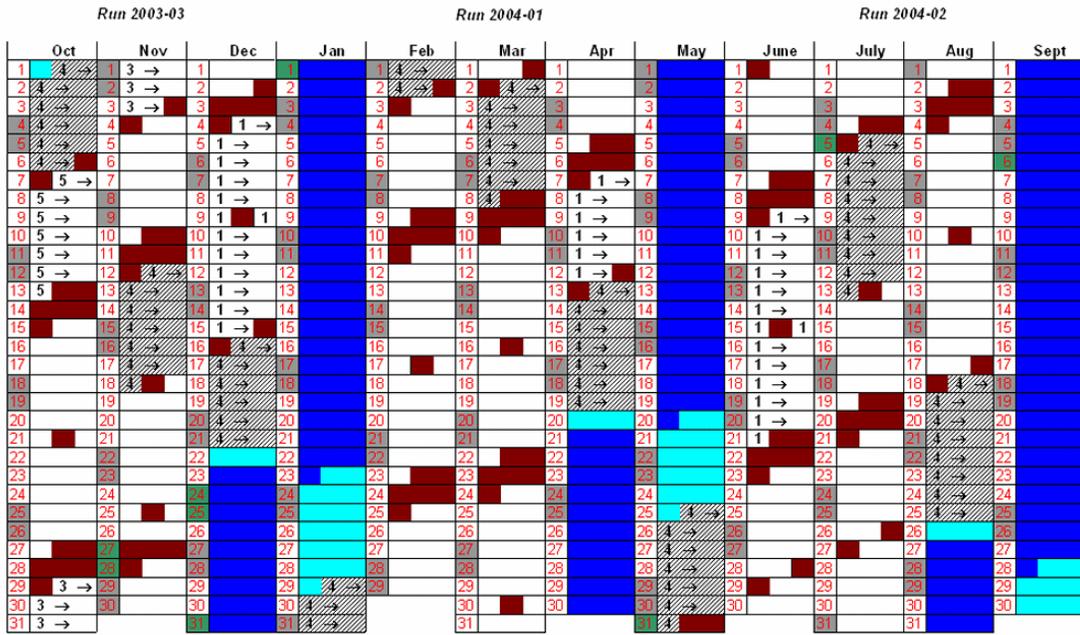
APS FY2004 Long Range Operations Schedule (October 2003 - September 2004)

| <ul style="list-style-type: none"> Top-up User Operation in low emittance mode Non top-up User Operation Fill pattern is 24 singlets unless otherwise indicated | <p>SOM Periods</p> <ul style="list-style-type: none"> 1 Hybrid Fill - (singlet) 2 Hybrid Fill - (triplet) 3 110 mA - Low E. singlets 4 324 Singlets - Low E. Fill 5 23 Singlets - Low E. | <ul style="list-style-type: none"> Machine Studies Maintenance Shifts set aside for Studies/ Machine Intervention as Needed Weekends Lab Holidays |
