## **ASD Quarterly Bulletin** **August - September, 2016**

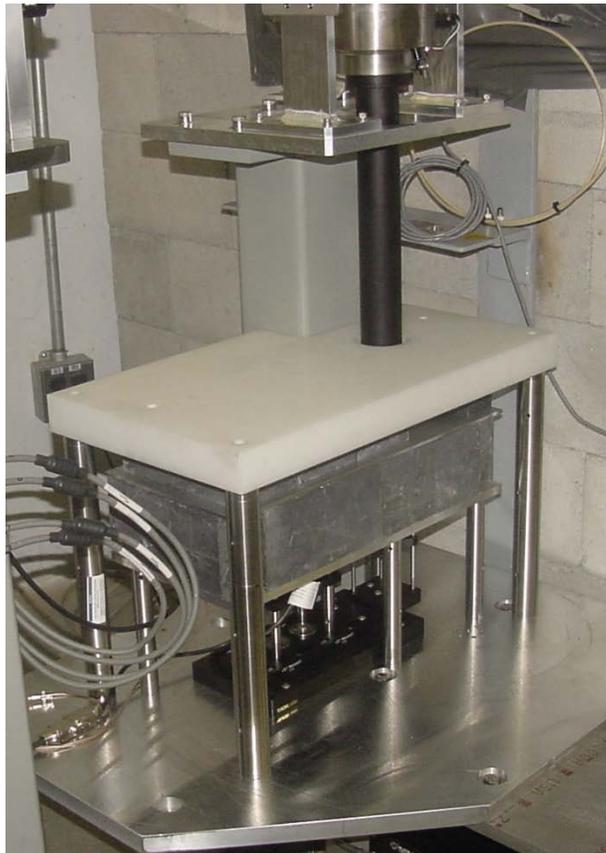
Booster beam dump (BTX) Transverse Profile Monitor prototype imaging hardware located under the electron beam vacuum pipe just upstream of the dump shielding wall.

The booster beam dump Transverse Profile Monitor (pictured) was upgraded in support of the MBA injector kicker development R&D program. This electron beam imaging system will help to characterize the beam displacement produced by the newly installed BTX Kicker; providing higher resolution centroid tracking of the electron beam. A large format single crystal YAG:Ce beam conversion target replaced the original fluorescent screen material that inherently has the limitations of large grain size, saturation effects at high charge and a long decay time. The single crystal YAG and associated renewed imaging hardware will enhance our ability to resolve and measure nominal machine operations based electron beam profiles and the much smaller beam spot sizes at high charge as exhibited during MBA kicker studies. The hardware platform produced here is a first round prototype design that will eventually replace similar APS injector beam imaging stations addressing the needs and goals of the MBA project.
